REPORT ON DAMAGES TO OYSTER RESOURCES IN TEXAS PRIVATE LEASES 390A, 391A, 392A & 432A DUE TO CHEMICAL SPILL ON MAY 10, 2019

Located in
GALVESTON BAY
GALVESTON COUNTY, TEXAS

DAMAGES TO OYSTER RESOURCES IN LEASES 390A, 391A, 392A,
427A & 432A FROM CHEMICAL SPILL ON MAY 10, 2019

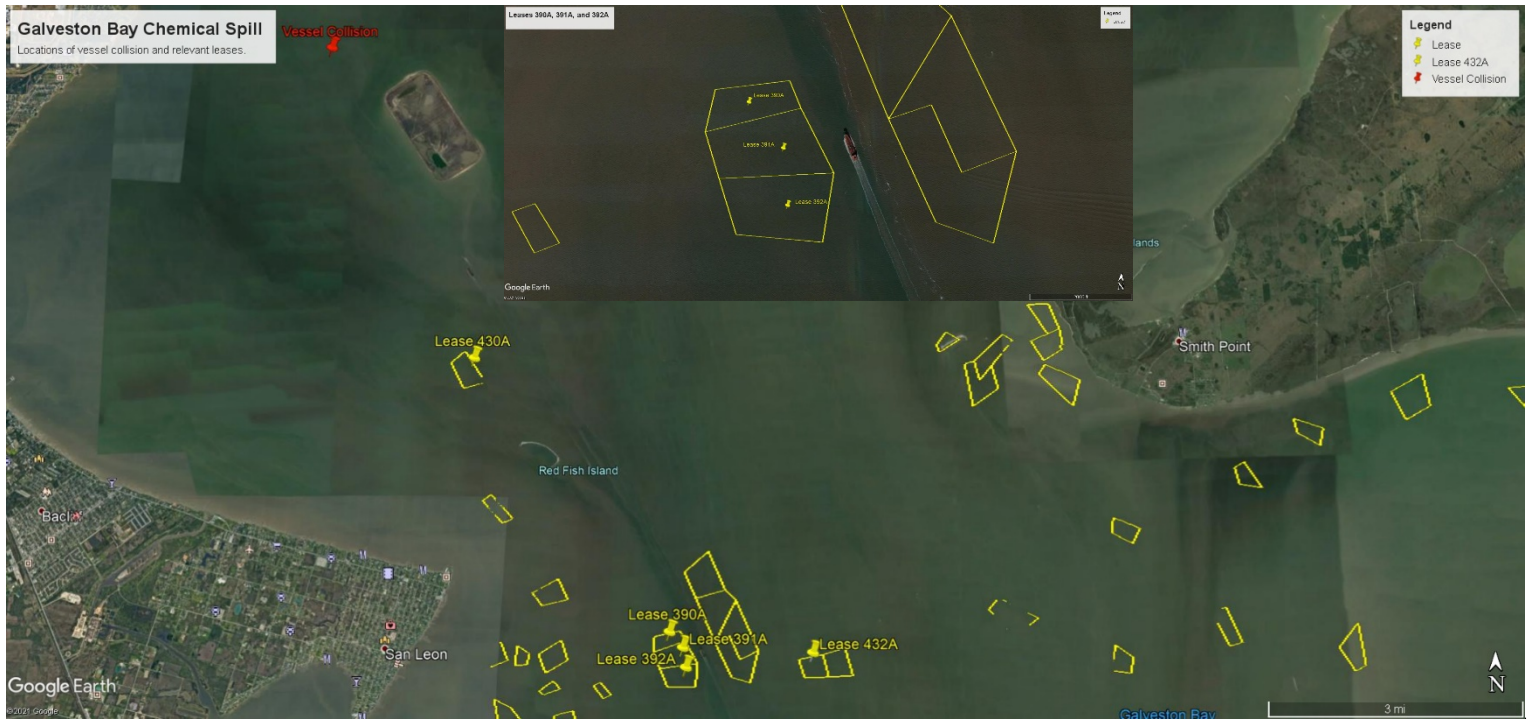
Figure 1. Map of Galveston Bay and private oyster leases. Relevant leases and the site of the vessel collision are noted. The inset map shows the three conjoined leases 390A, 391A, and 392A.

In the years prior to the chemical spill in 2019, MREC was tasked with surveying the three leases repeatedly, and so have relevant data standing crop densities, natural mortalities, and acreage calculations of oyster bearing water bottoms for the leases 390A, 391A, and 392A. Water bottom surveys were performed in 2015, and oyster samples were taken in 2015, 2016, and 2017 (after Hurricane Harvey). Dive samples were taken again in August of 2019, two months after the chemical spill. For the purposes of this report and simplification of reporting damage, as the three leases are immediately adjacent to each other (Appendix A, Figure 1), the data for all three leases were combined and treated as one lease area.

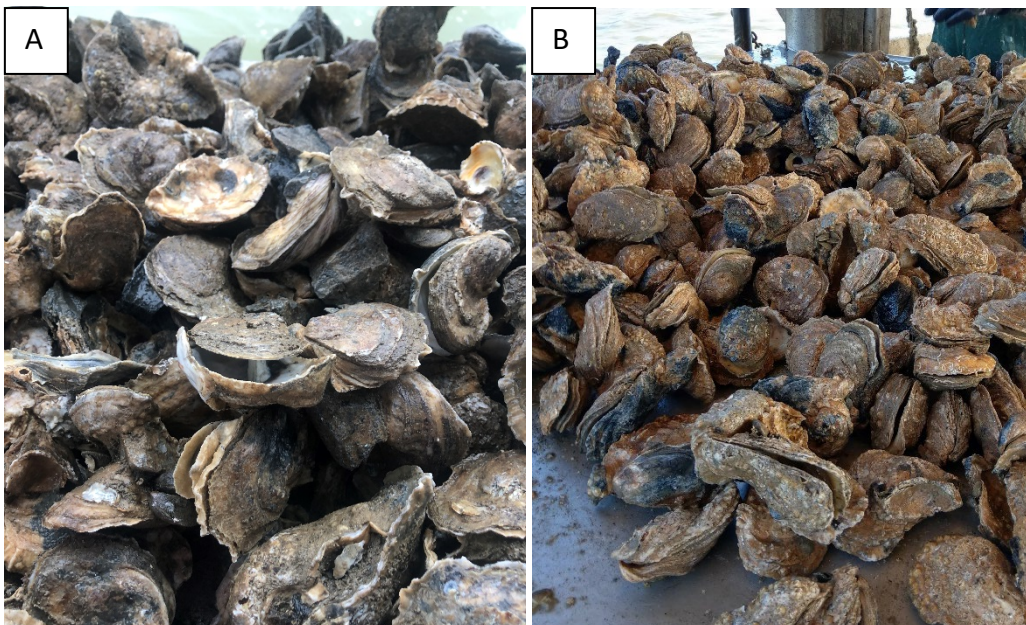
Figure 2. A) dredge samples harvested on leases 390A, 391A, and 392A. B) Dredge samples harvested on lease 430A. Note the high number of recent dead boxes, many with oyster tissue still remaining inside.

It is readily apparent that the chemical spill had a devastating effect on the standing crop of oysters throughout the area of Galveston Bay. Multiple lease operators in the Galveston Bay area noted shortly after the spill that oysters harvested were found to be recently dead, noting high numbers of open boxes, with oyster flesh still inside (Appendix A, Figure 2). MREC was contacted in order to accurately survey some of the leases in question and accurately estimate the standing crop which was lost.
